Performance of the Low-energy House in Sisimiut

Carsten Rode^{1,*}, Jesper Kragh², Egil Borchersen¹, Petra Vladykova¹, Simon Furbo¹ and Janne Dragsted¹

¹ Technical University of Denmark

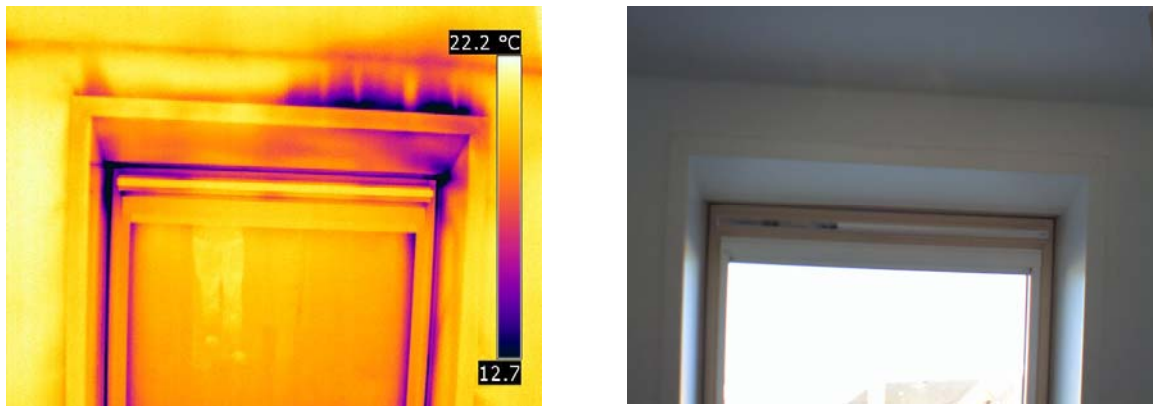
Figure 5. Infrared and normal picture of north-west facing window taken during blower door test.

A so-called blower door test has been carried out on February 7, 2009. The test showed an average leakage of 3.2 h^{-1} measured at 50 Pa over- and under-pressure. While this air leakage is not too high compared to the Greenlandic Building Code, since there are no requirements, it is significantly above the requirement imposed since 2006 in the Danish Building Code, that the air change must not exceed 1.5 h^{-1} when measured at 50 Pa pressure difference. Problem areas were identified around windows, at floor joints, at electrical outlets, and possibly under the floor (see Figure 5).

For a building which is not in a sheltered environment, it can be expected that the free air change due to infiltration/exfiltration, n_{inf} is around 10% of n_{50} (DIN, 2003) and thus infiltration/exfiltration in the house can be expected to be around 0.32 h^{-1} . The volume of air in the building is 530 m^3 , and thus the annual ventilation heat loss associated with this air change can be estimated to be 68 kWh/m^2 (based on the average outdoor temperature: -3.9°C). The assumption when designing the house was that the infiltration/exfiltration air flow would be only 0.1 h^{-1} , and thus the annual extra energy consumption due to poor air tightness of the building envelope, amounts to approximately 45 kWh/m^2 .
